**CHECK AND SET IGNITION TIMING IN ADVANCED POSITION
ELECTRA GLIDE / SPORTSTER / SERVI-CAR**

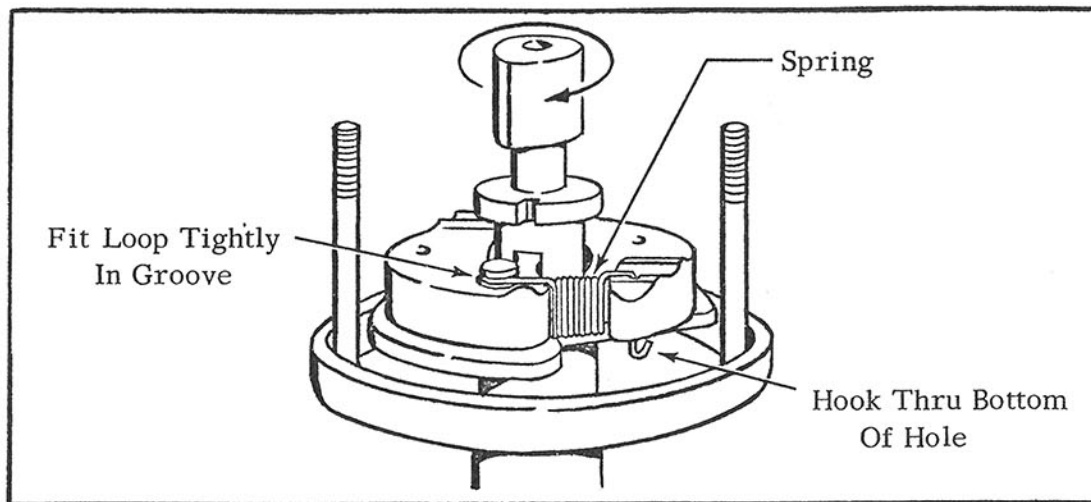
Before making ignition timing check, remove circuit breaker plate stud nuts, remove plate cover and check to see that cam flyweights move freely. It is most important that the cam returns to the retard position when the engine is stopped. Failure to retard fully usually causes starter drive failure.

On 1967 and later models, also see that bent end of each flyweight spring is hooked through bottom of hole and see that upper looped end of each spring grips retaining groove in pin tightly.

Replace breaker plate cover and set circuit breaker point gap at .020 in. before checking and setting advanced ignition timing.
