MODEL HD CARBURETOR ACCELERATING PUMP CHECK VALVE

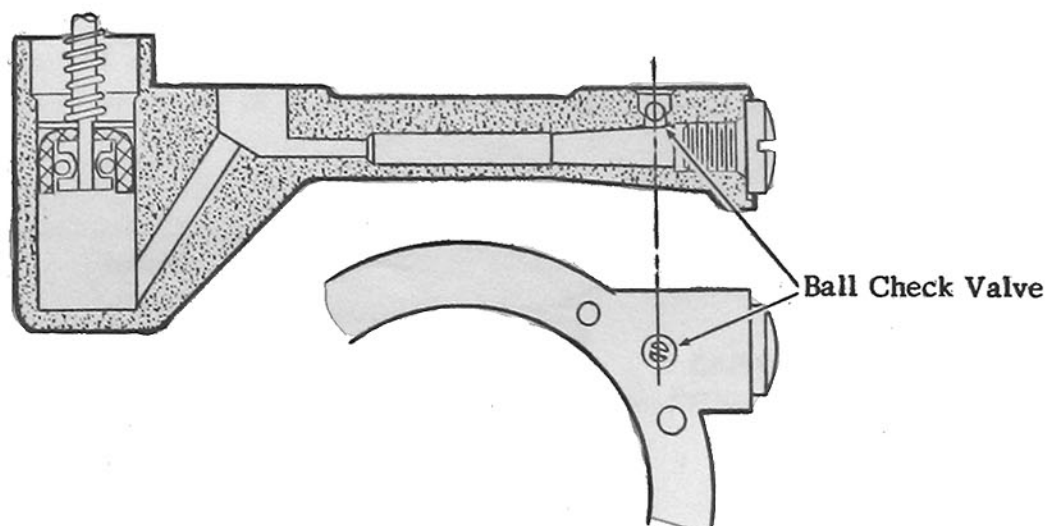
Late 1968 Sportster and Electra Glide Model Carburetors were recently changed to incorporate a ball check valve in the accelerating pump passage of the plastic cover. The illustration below shows the pump discharge passage and check valve, which provides a positive seal against air bleeding back from venturi into fuel chamber.

If air bleeds into fuel chamber through the accelerating pump passage, the following symptoms may occur:

- Poor or erratic accelerator pump action.

- Surging at cruising speeds accompanied by hesitation when rider attempts to accelerate from a given cruising speed.

- A "vapor lock" complaint when motorcycle is operated at low speeds after being operated at higher speeds.

- A tendency to stall when engine is idled.

Electra Glide carburetor, part No. 27160-66B, incorporating the new ball check valve, is stamped HD-2D or HD-2CD on the intake manifold flange.

Sportster carburetor, part No. 27162-66B, incorporating the new ball check valve, is stamped HD-1BC or HD-1C.

Pump body, part No. 27804-66A, now supplied for parts orders, has the new ball check valve and replaces part No. 27804-66, which did not have ball check valve.
